The Design
and
Methods of Construction
of
Welded Steel Merchant Vessels

FINAL REPORT OF A BOARD OF INVESTIGATION

To Inquire Into
THE DESIGN
AND METHODS OF CONSTRUCTION
OF WELDED STEEL MERCHANT
VESSELS

15 JULY 1946

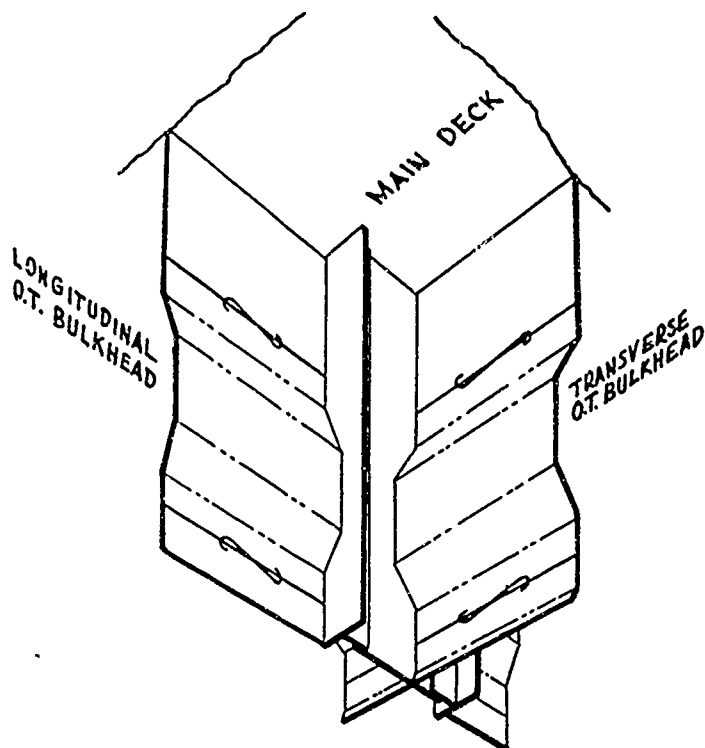
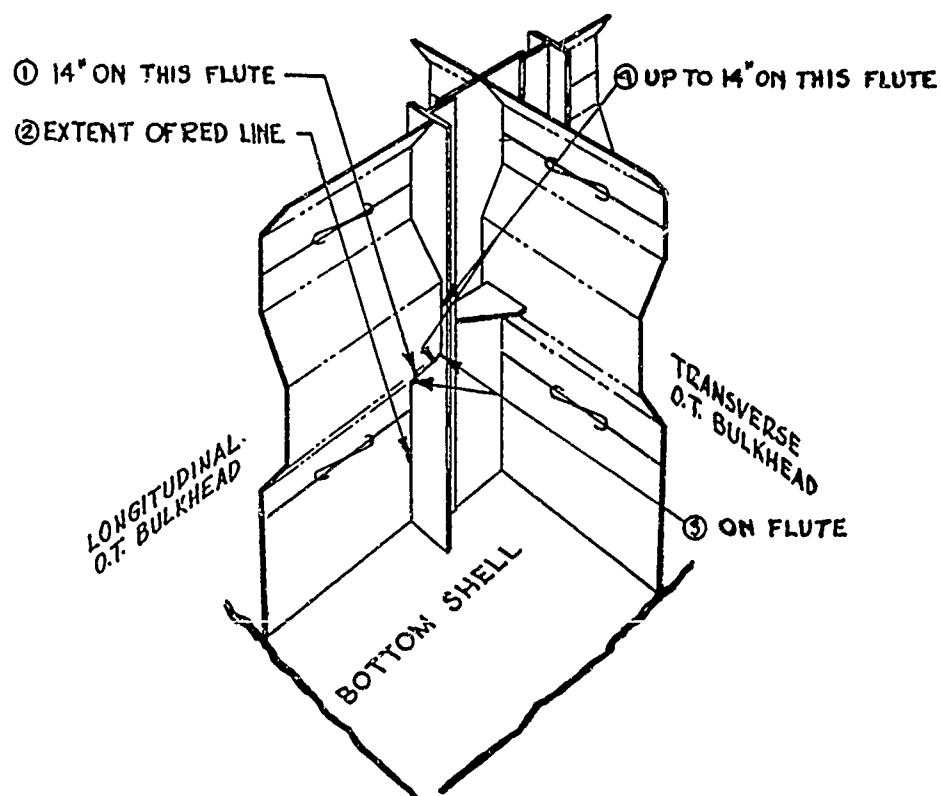
Figure 39.

T2-SE-A1 TYPE
COMPOSITE SKETCH OF FRACTURES
CONNECTION OF FLUTED LONGITUDINAL BULKHEADS TO TRANSVERSE BULKHEADS

UP TO 1 AUG. 1945 325 FRACTURES
 WERE REPORTED AT THESE
 BULKHEAD INTERSECTIONS.

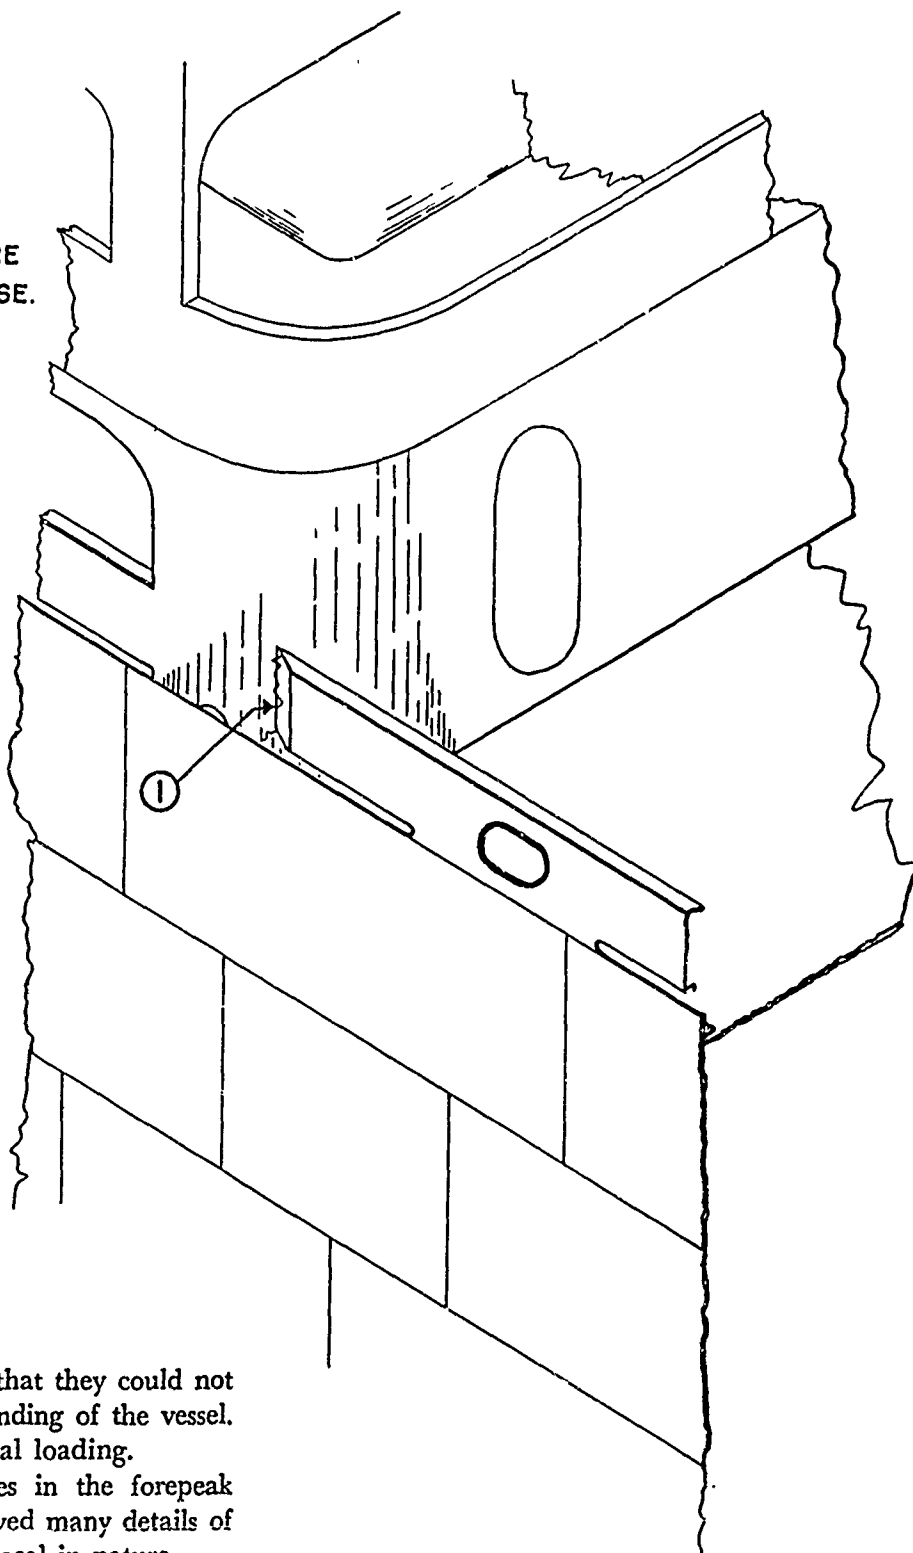
Figure 41.

VICTORY SHIP
TYPICAL BULWARK FRACTURE
AT FWD. END OF DECK HOUSE.

Most of the bulwark failures occur at the forward and aft end of the deck house where the bulwark is flanged to land perpendicular to the rounded house front, figure 41. This is a poor design detail but is not a dangerous feature because experience with the Liberties led to constructing the Victory bulwarks free of the top of the sheer strake. This freedom prevents the cracks from propagating into the hull.

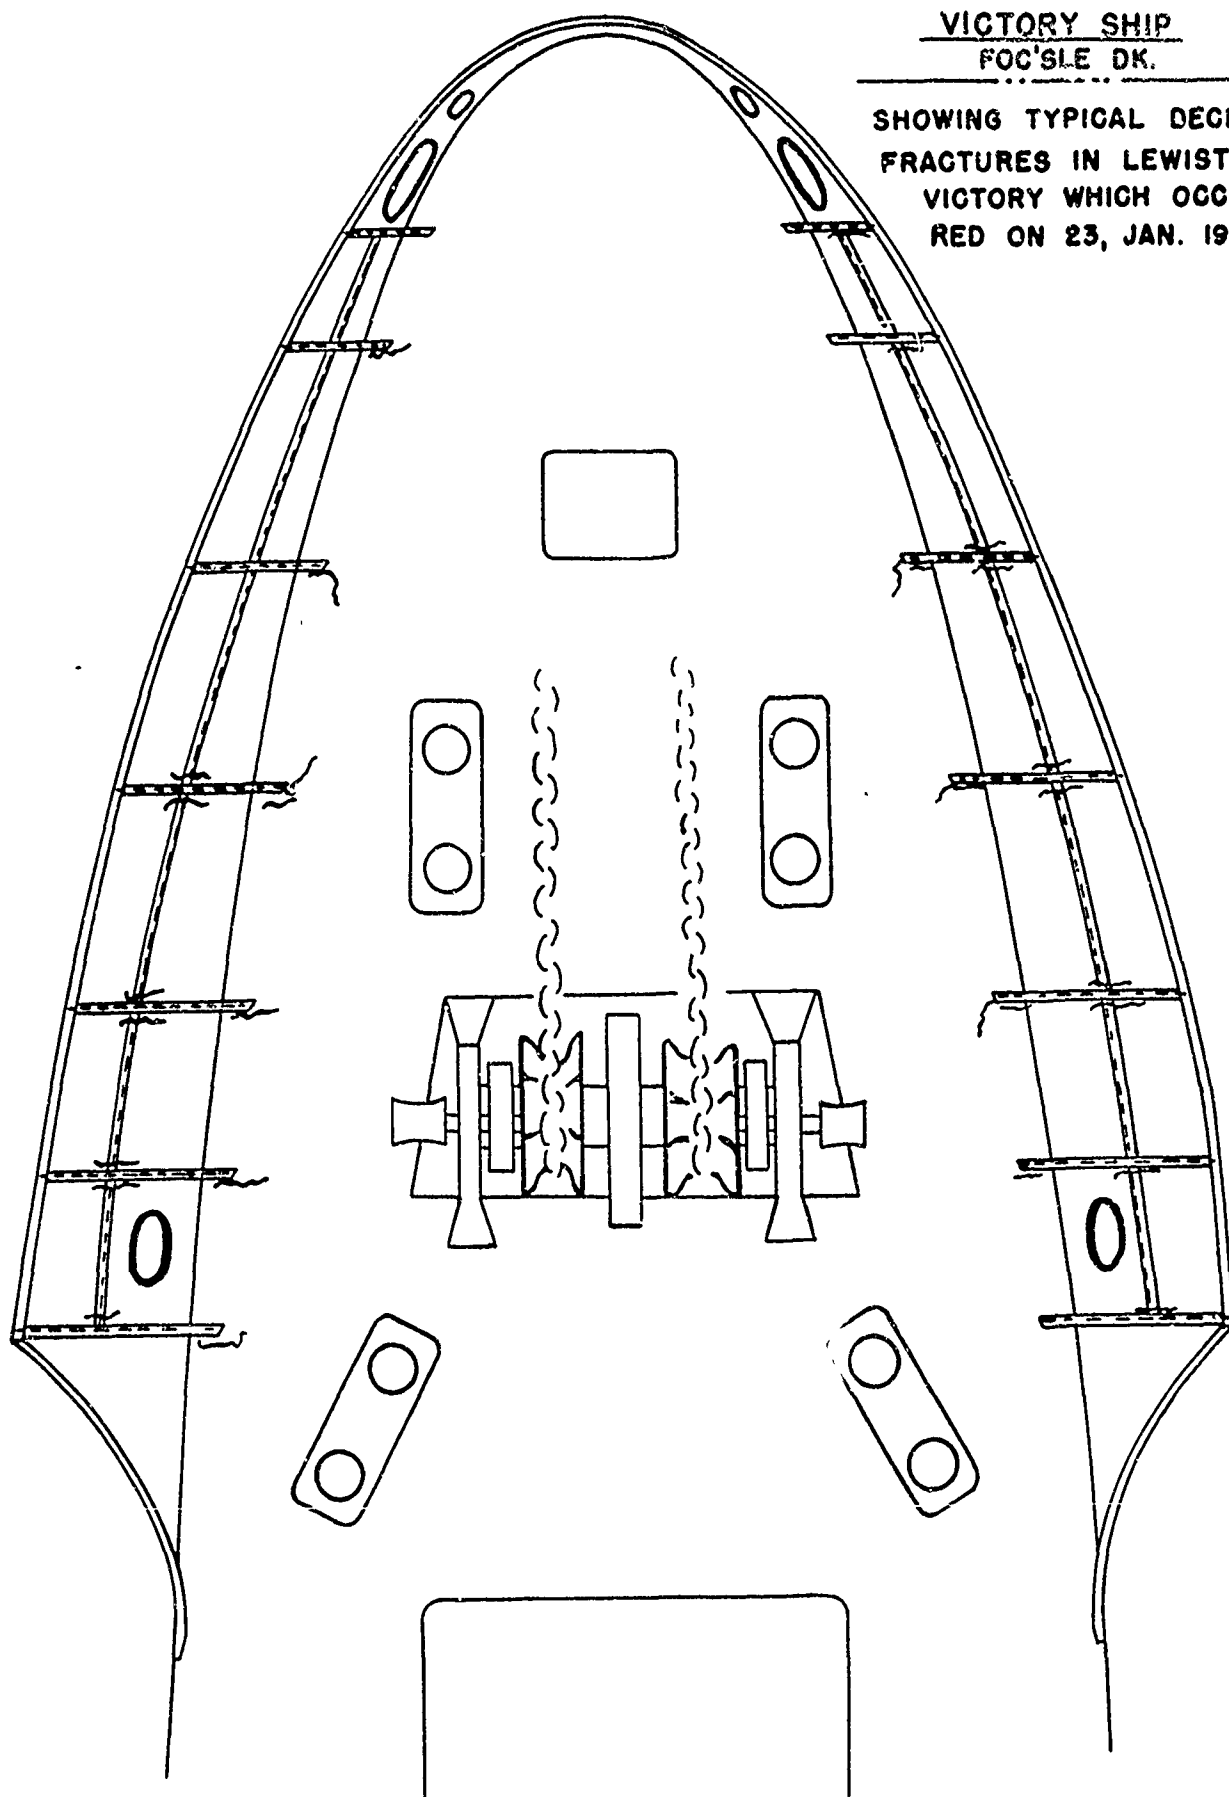
Figure 42.

SHOWING TYPICAL DECK
FRACTURES IN LEWISTON
VICTORY WHICH OCCUR-
RED ON 23, JAN. 1948

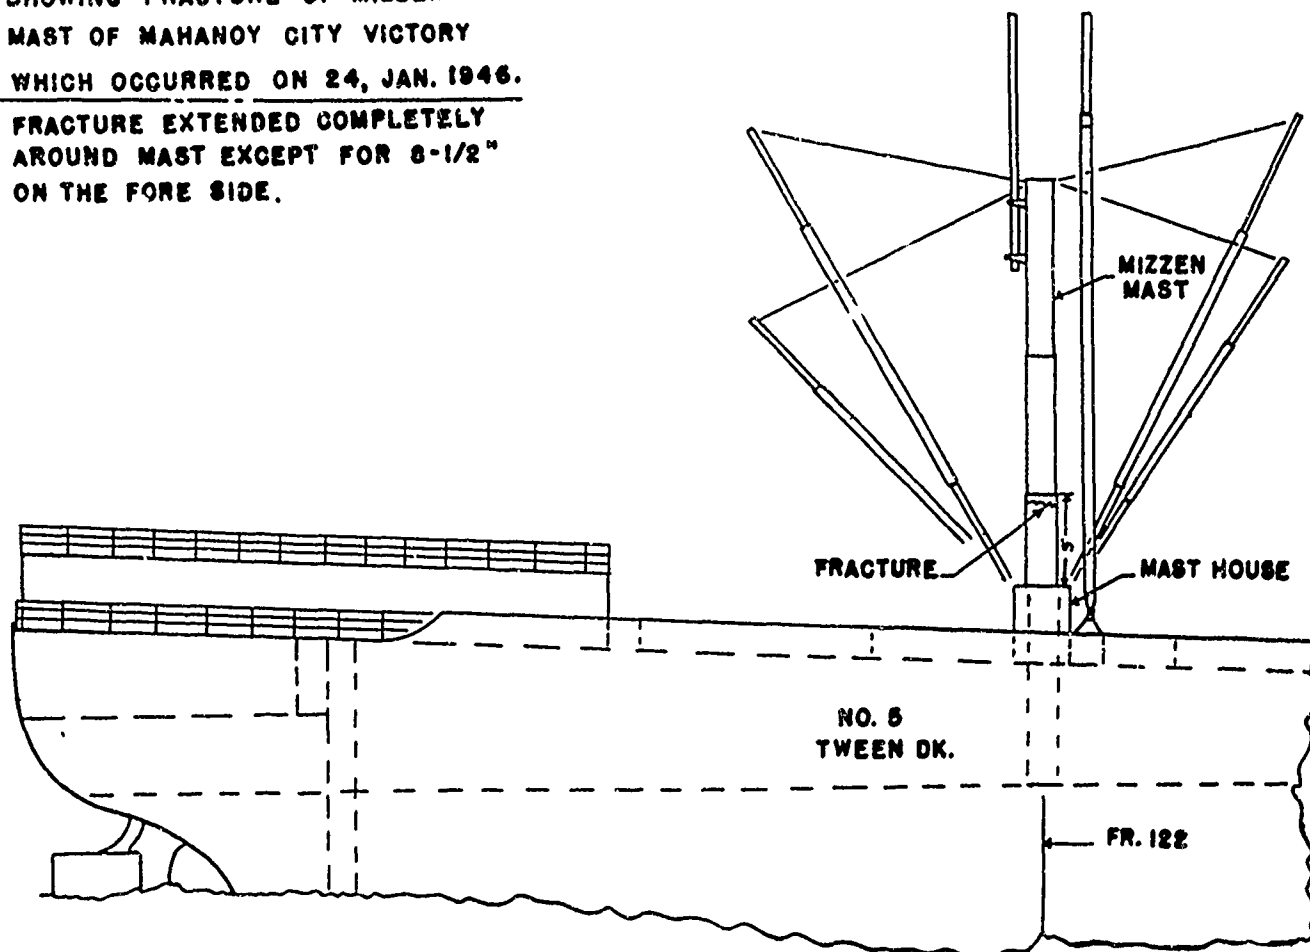
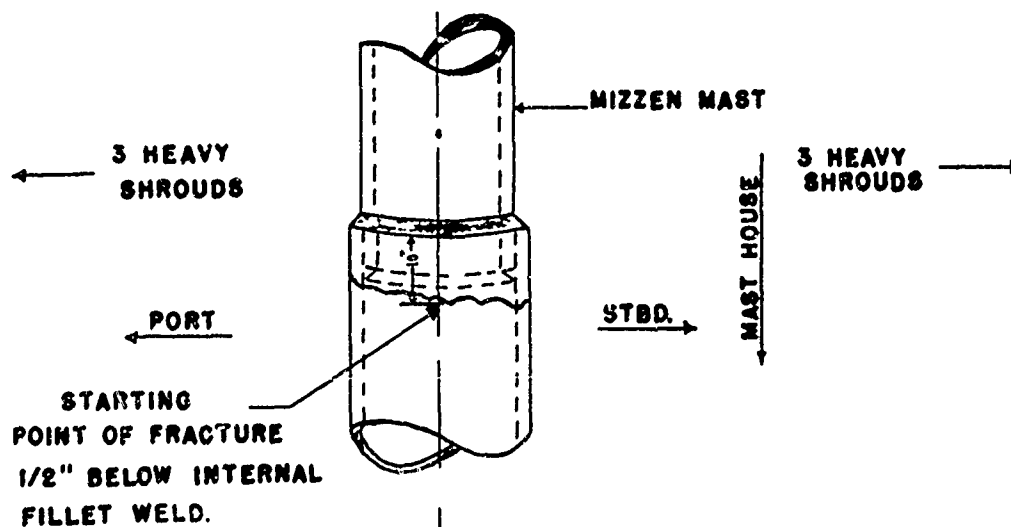
Figure 43.

FRACTURE EXTENDED COMPLETELY
AROUND MAST EXCEPT FOR 8-1/2"
ON THE FORE SIDE.

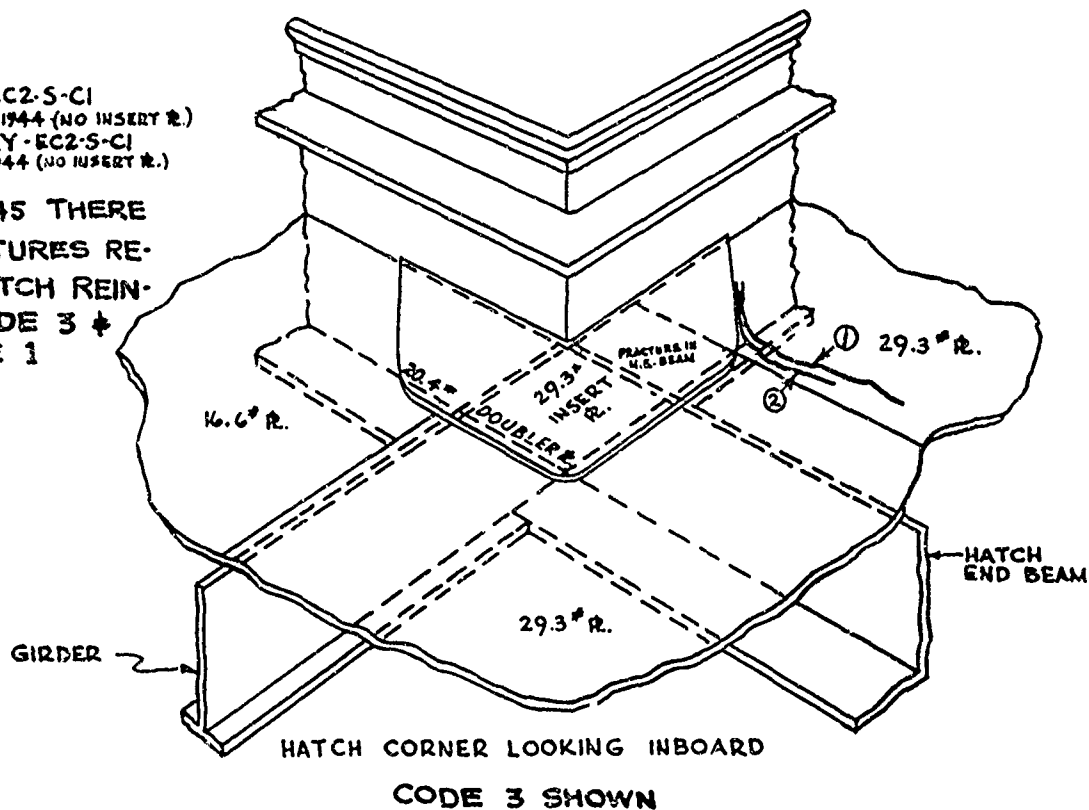
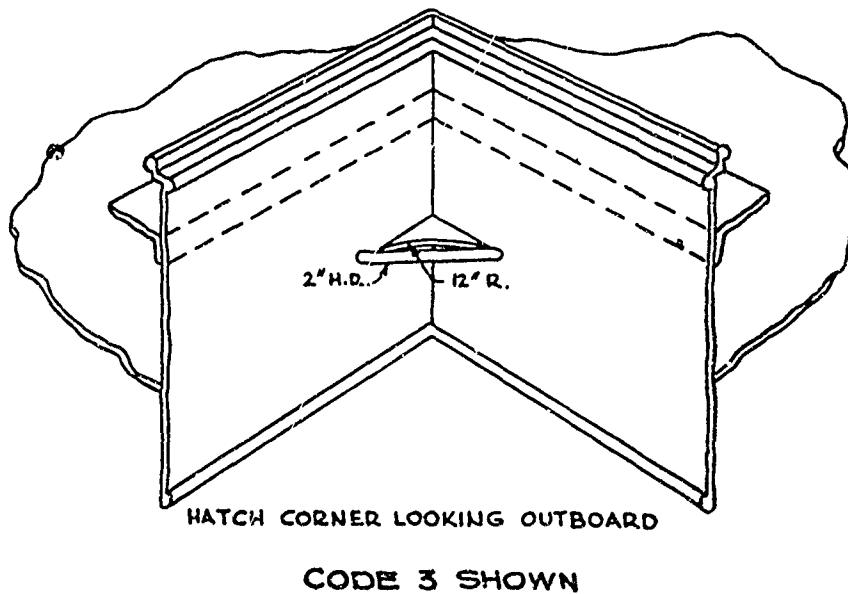
Figure 47.

UP TO 1, AUG. 1945 THERE
 WERE 5 FRACTURES RE-
 PORTED ON HATCH REIN-
 FORCEMENT, CODE 3 &
 NONE ON CODE 1

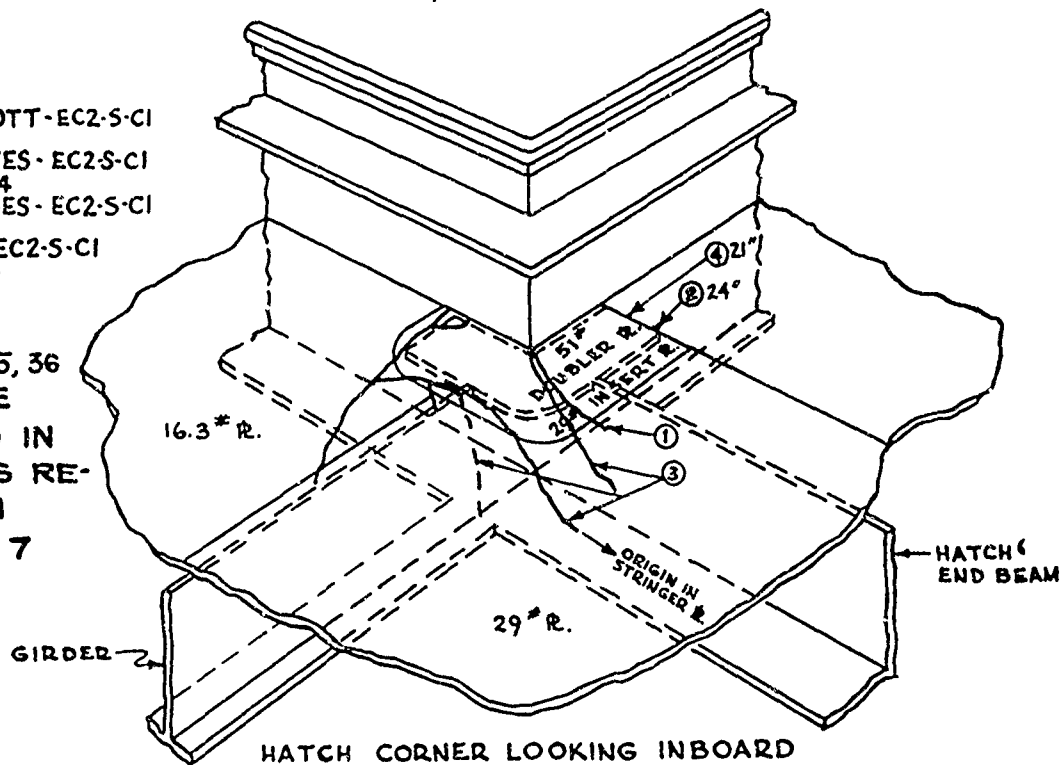
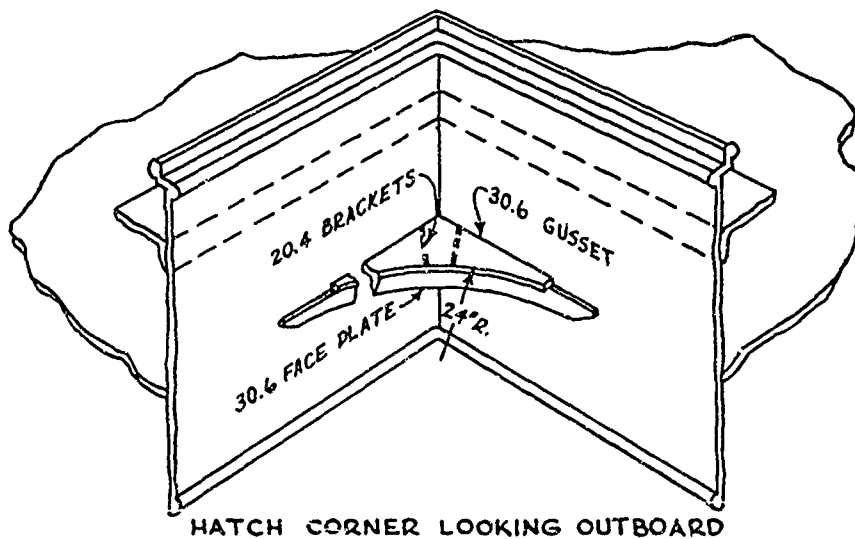
Figure 48.

UP TO 1, AUG, 1945, 36
 FRACTURES HAVE
 BEEN REPORTED IN
 HATCH CORNERS RE-
 INFORCED WITH
 CODES 5, 6, & 7

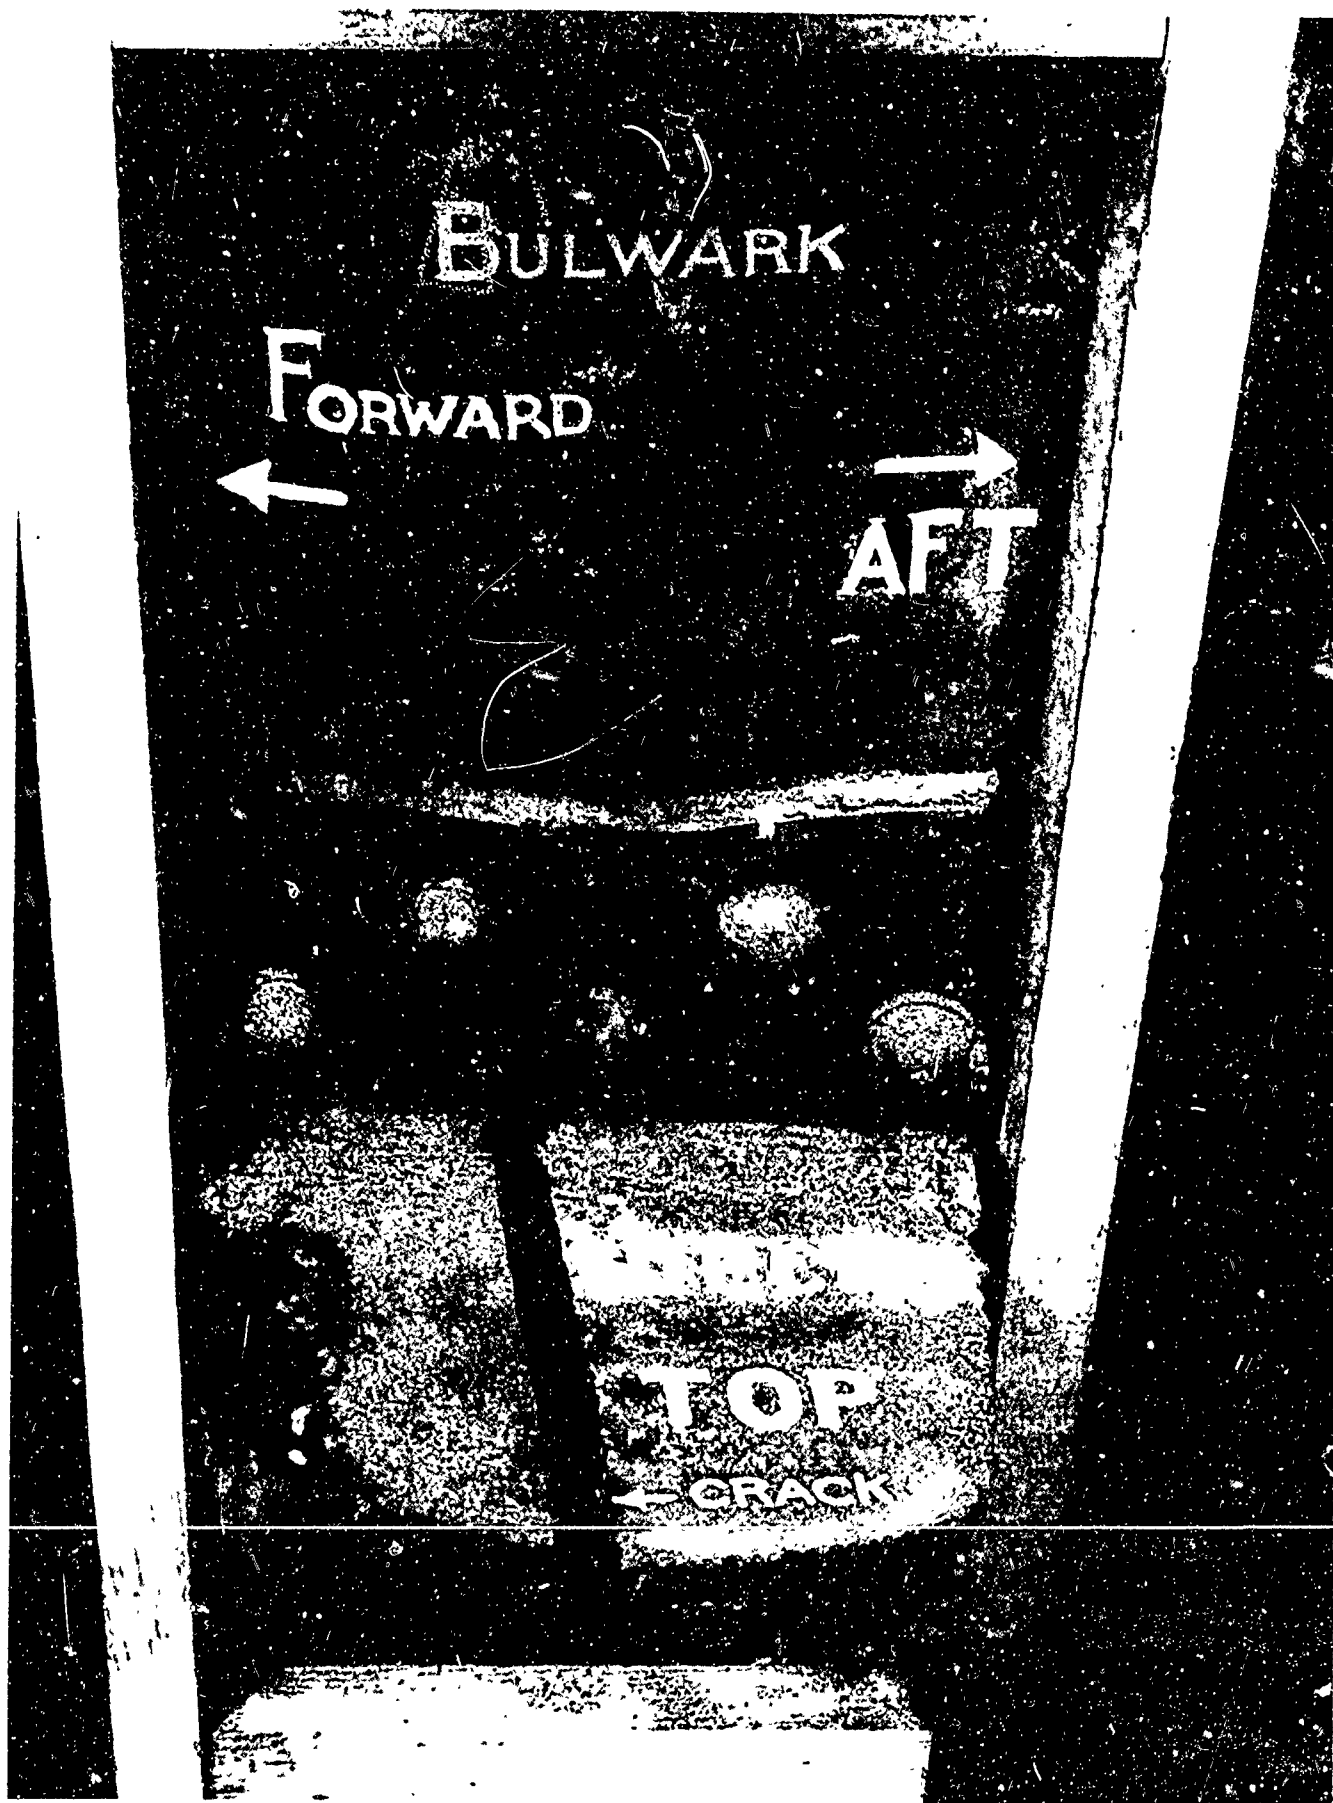
FIGURE 51. —Termination of fracture at gunwale, starboard side, S. S. Colin P. Kelly Jr. (see arrow fig. 53.)

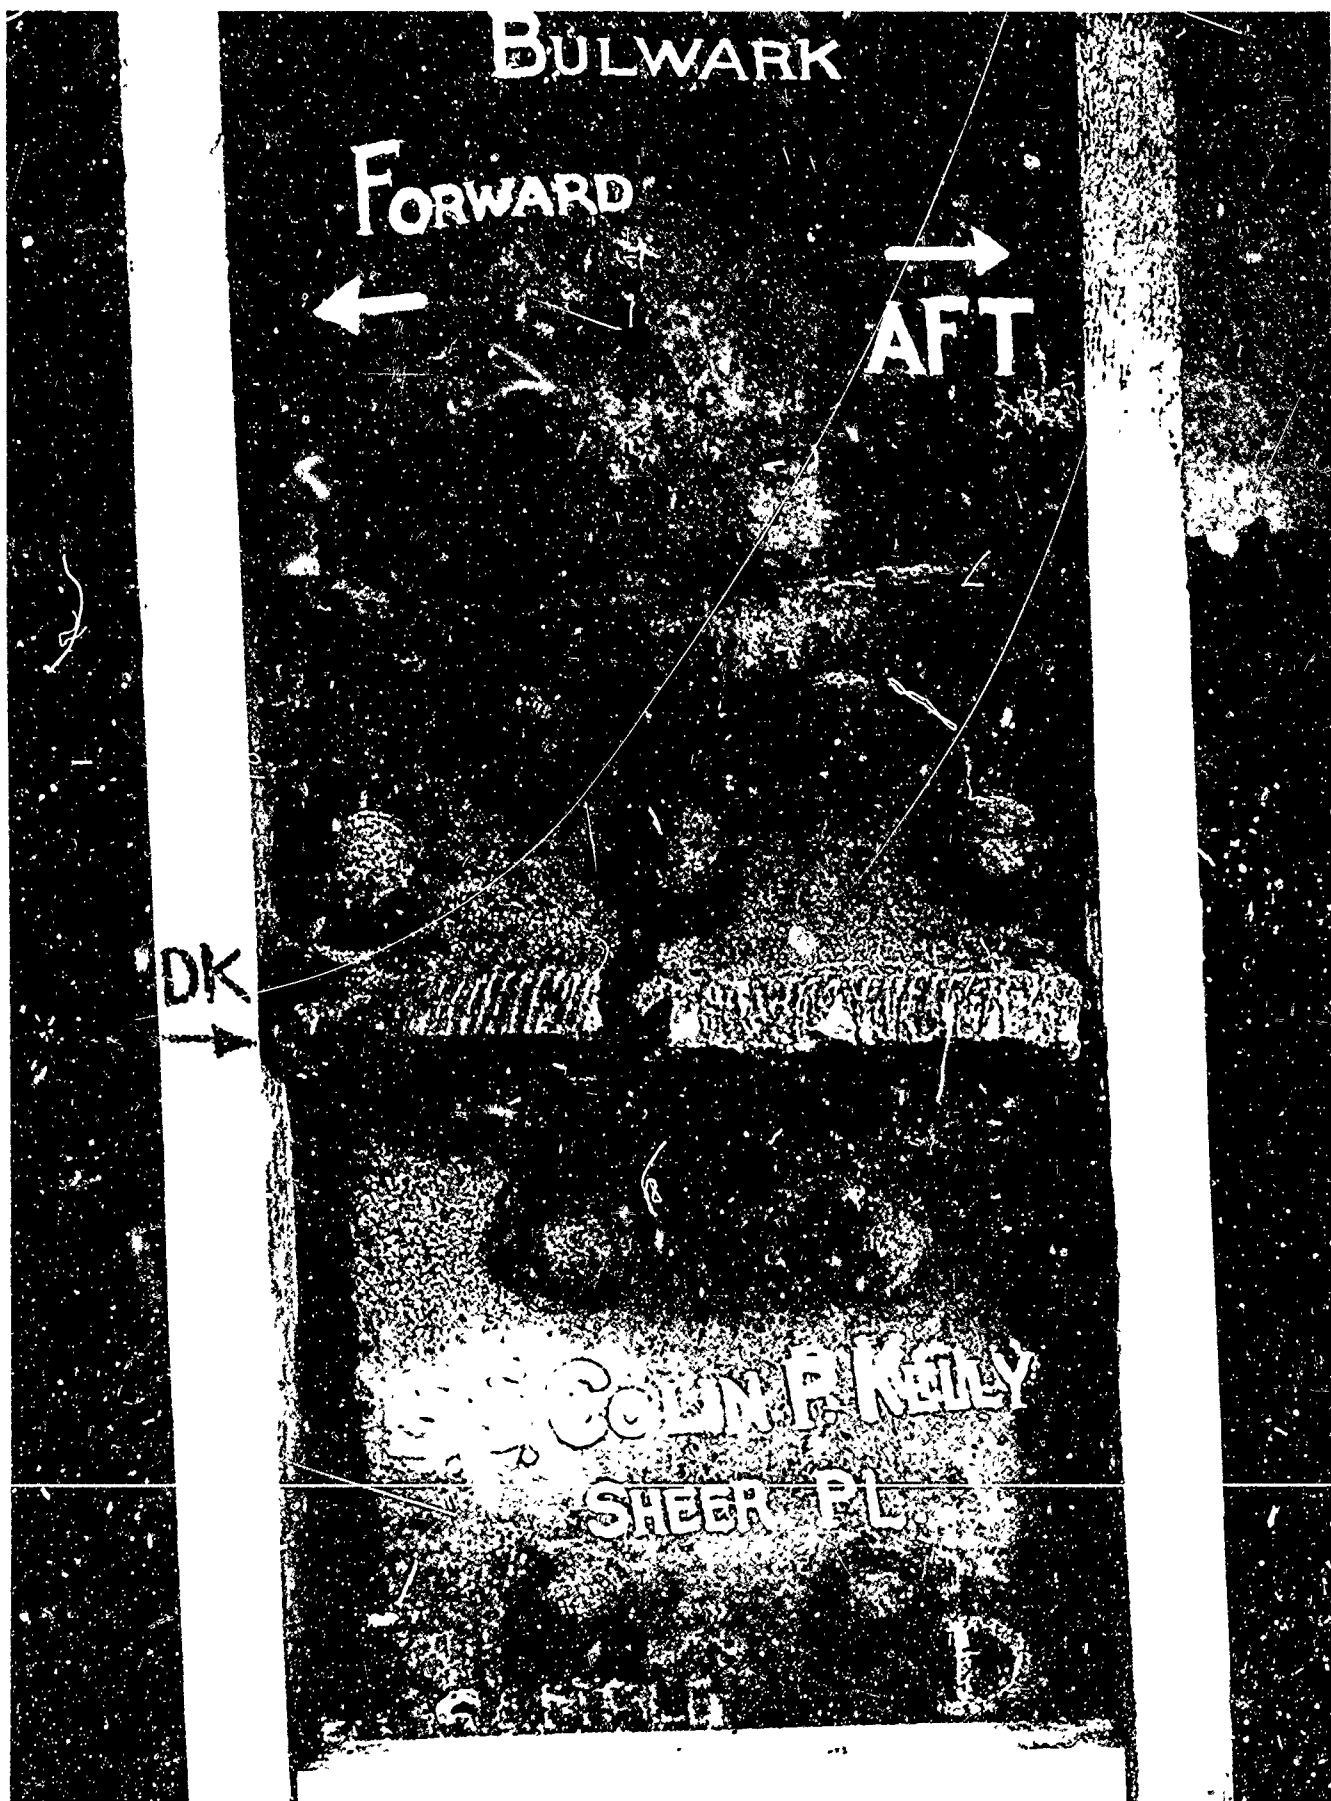
FIGURE 55 Termination of fracture at gunwale, starboard side, S. S. *Colin P. Kelly Jr.* (Note horizontal torch cut below deck, see fig. 52.)

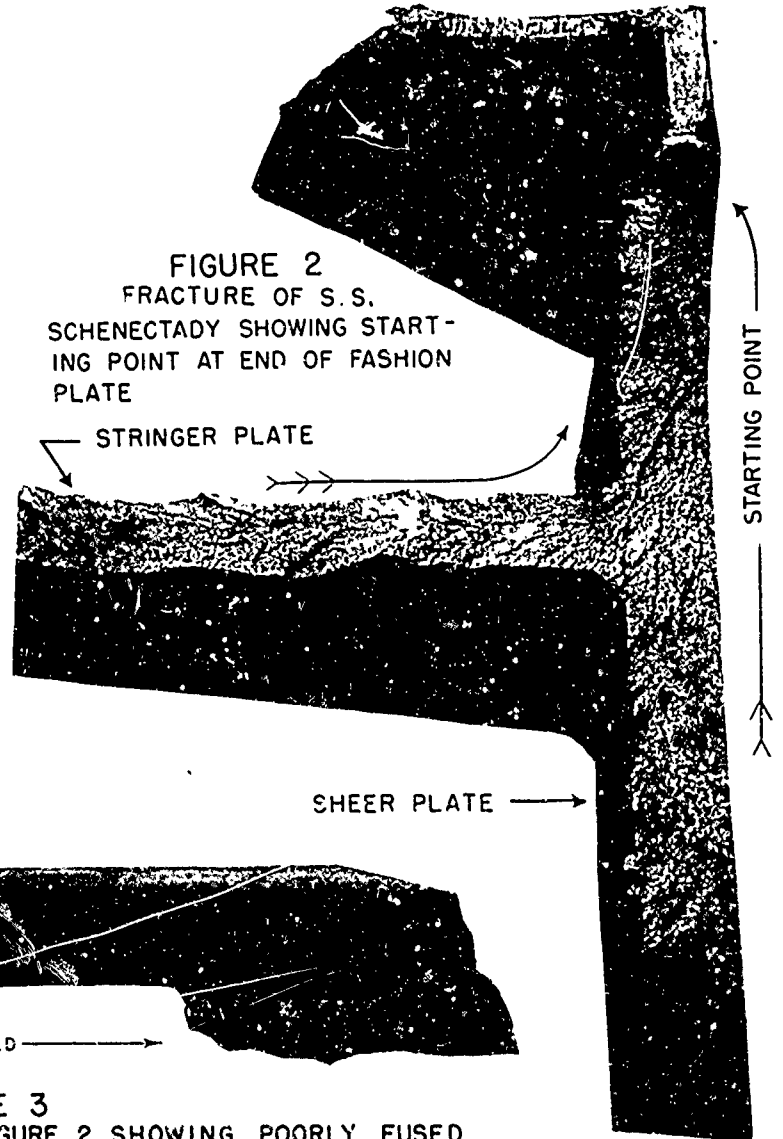
FIGURE 2
FRACTURE OF S.S.
SCHENECTADY SHOWING START-
ING POINT AT END OF FASHION
PLATE
